# Galligu and TPH Contaminated Site Remediation in Runcorn, UK

## Integrated geo-environmental solution allows for site redevelopment

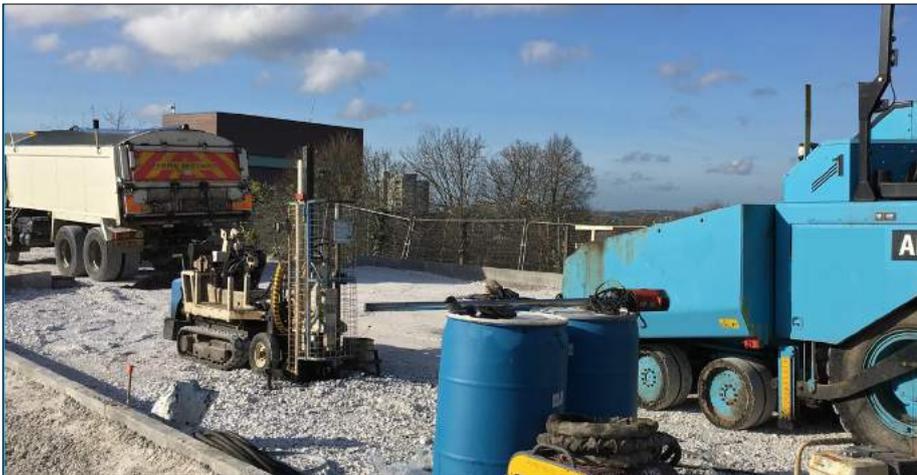
Fig. 1 - PlumeStop barrier injection near site boundary

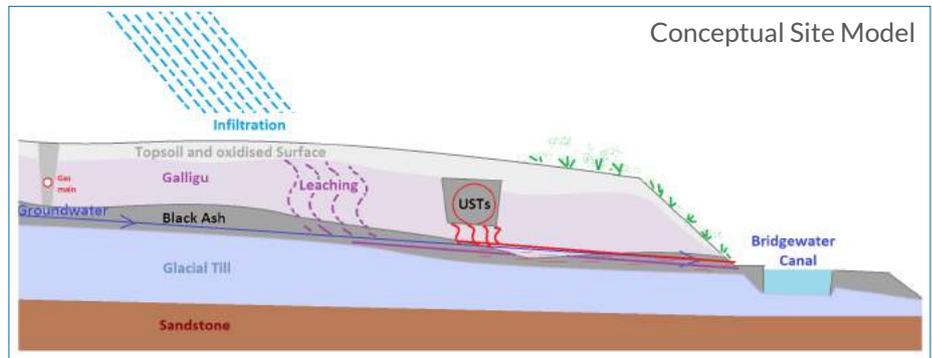
Fig. 2 - Conceptual Site Model in Section

The site comprised a hillside covered by industrial waste from the Leblanc process comprising several metres of galligu above a black ash layer which was underlain by cohesive glacial till. Two geoenvironmental issues needed addressing:

1. **Stability:** the galligu had a weak structure, with a 'toothpaste' consistency in parts;
2. **TPH contamination;** leaking underground storage tanks (UST)s onsite resulted in fuel infiltrating the subsurface and moving offsite via perched water in an ash layer beneath the galligu.

The downgradient boundary comprises a steep slope to the canal where the contaminated groundwater egressed at ground-level, polluting the waterway.

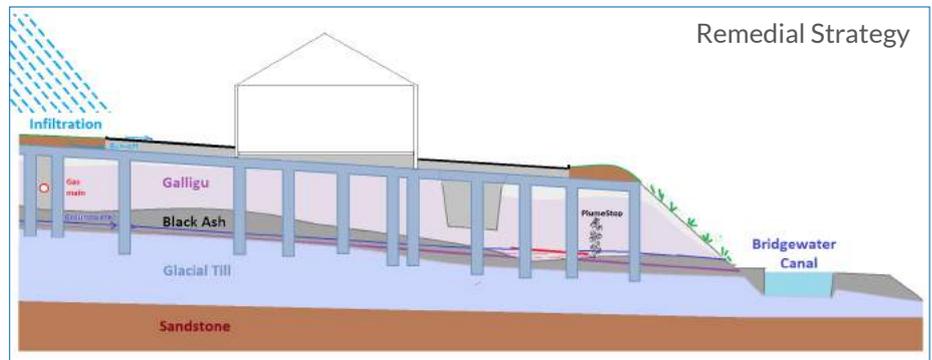
Fig. 3 - Remedial Strategy in Section

An integrated solution: Soil/cement mixed panels were used to support structures, with a soil/cement mixed mattress covering the entire site, as a load transfer platform. Installation of these panels altered the groundwater flow, which therefore needed modelling to ensure the contaminant treatment could be targeted accurately.

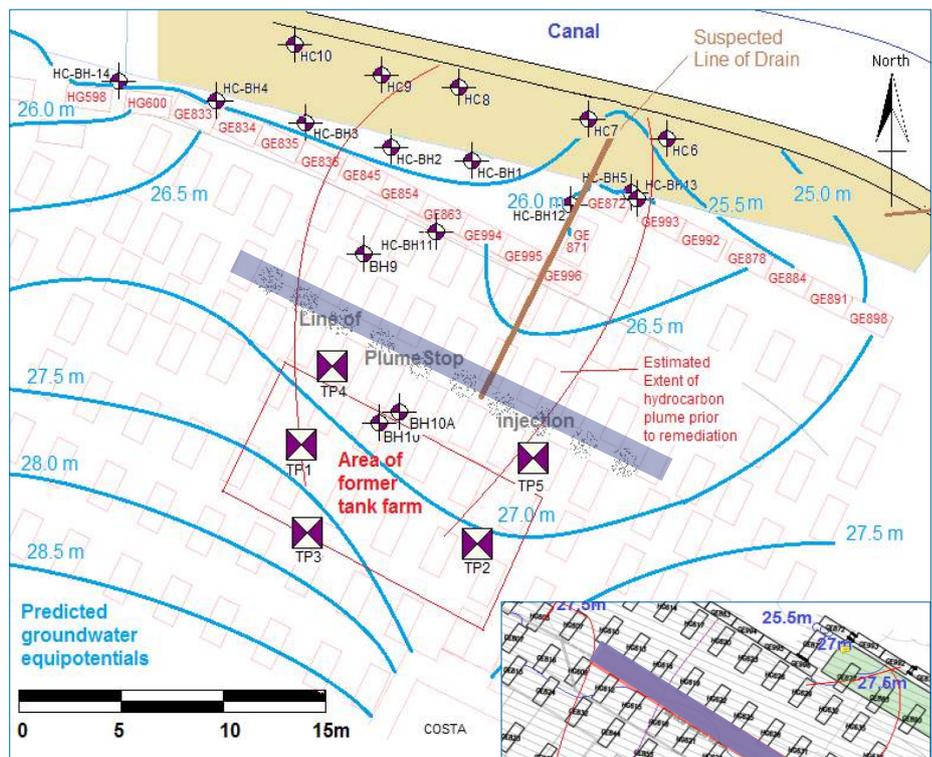
Fig. 4 - Modelled Groundwater Flow

Location of soil/cement mixed panels
-

Location of *in situ* LAC barrier

Modelling groundwater flow through anthropogenic waste and man-made installations presented a challenge, as models are designed for more homogeneous and isotropic conditions. However, it was shown that groundwater would be raised and channelled towards the panel 'wall' at the boundary. Here the groundwater would funnel through gaps at a higher velocity.

When PlumeStop Liquid Activated Carbon (LAC) was chosen, the placement of this underground filter needed to be carefully considered. At the boundary, the groundwater flow was extremely fast through the gaps. Hence, by moving the barrier into the site, the slower groundwater allowed for a longer treatment time in the PlumeStop. The PlumeStop barrier length was guided by the modelling, to transect the entire contaminant plume. REGENESIS provided bespoke design work to match the predicted groundwater flow and contaminant levels (i.e. the contaminant flux).

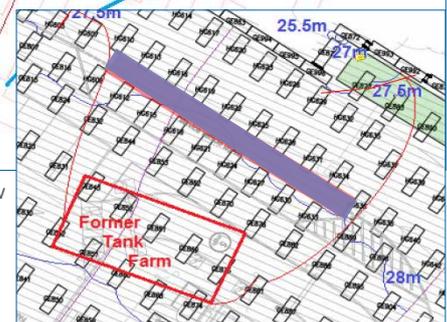
Fig. 5 - Injection Plan

**Area Treated:** 27m long barrier (10 points at 3m spacing)

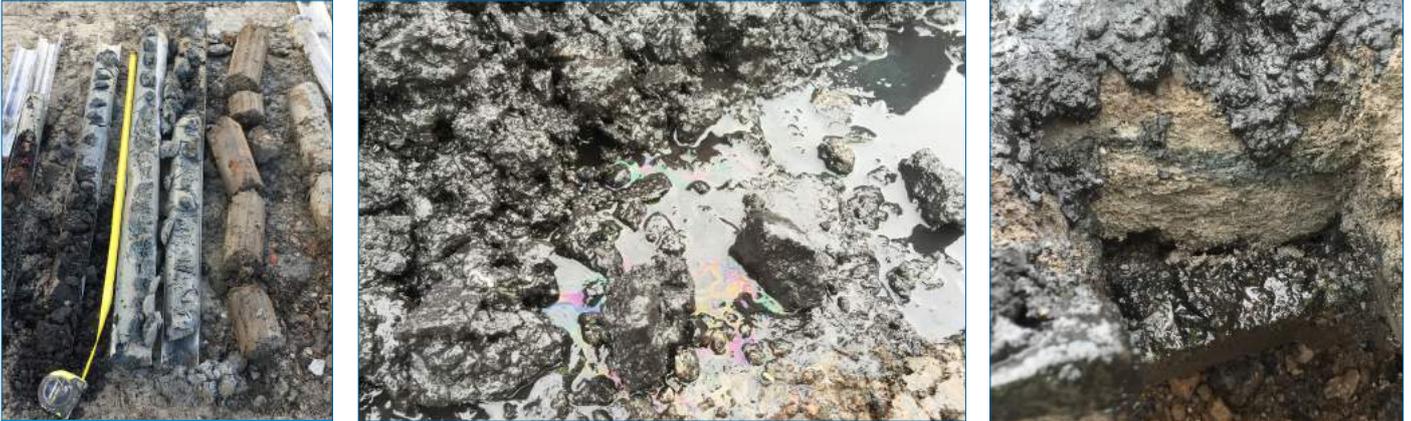
Fig. 6, 7 and 8 - TPH contamination and galligu on site

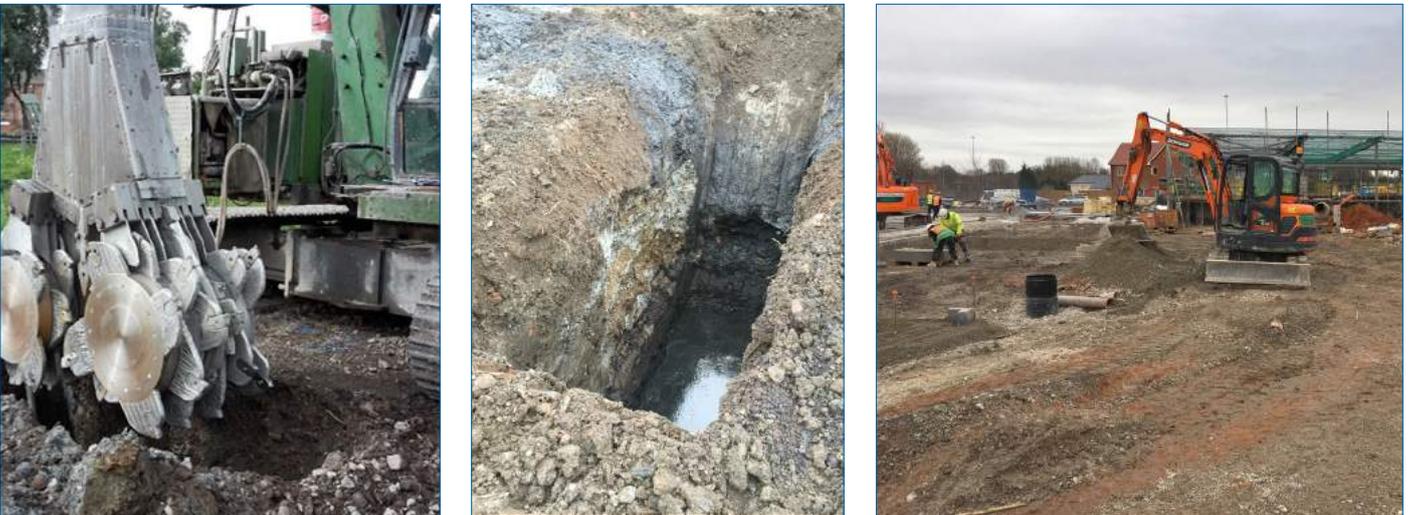
Fig. 9,10 and 11 - Installation of the soil-cement stabilisation panels by Deep Soil Mixing Ltd

The structure of galligu varied across the site: from fused crystalline 'rock' in upper areas, to a weak 'toothpaste' consistency at depth - unsuitable to build on. Previous settlement caused hydrocarbon leaks from broken pipes, resulting in the bus depot closure. Potential settlement prevented the use of a raft foundations. In addition, the presence of a high pressure gas main prevented the use of a piling solution. Therefore a soil/cement panel solution was piloted and then installed full scale by Deep Soil Mixing Ltd, using in situ mixing equipment (see figure 5 and 6).

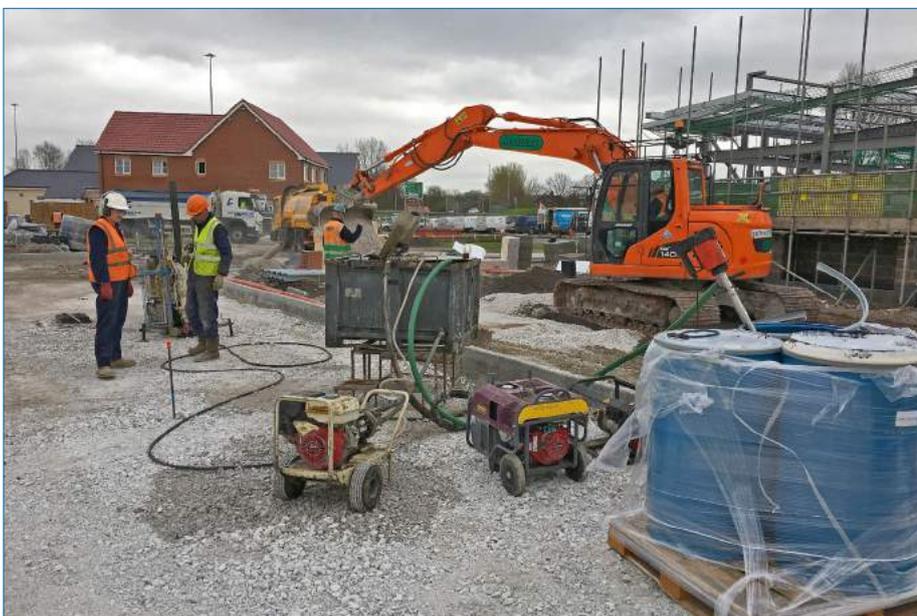
Fig. 12 - Injection of PlumeStop barrier by REGENESIS

REGENESIS worked with GEA and their client to ensure the design matched their requirements. REGENESIS also managed and completed the injection works onsite using direct push injection, and then provided a completion report and warranty. All work was completed on a busy construction site, with a high-pressure gas main and large easement.

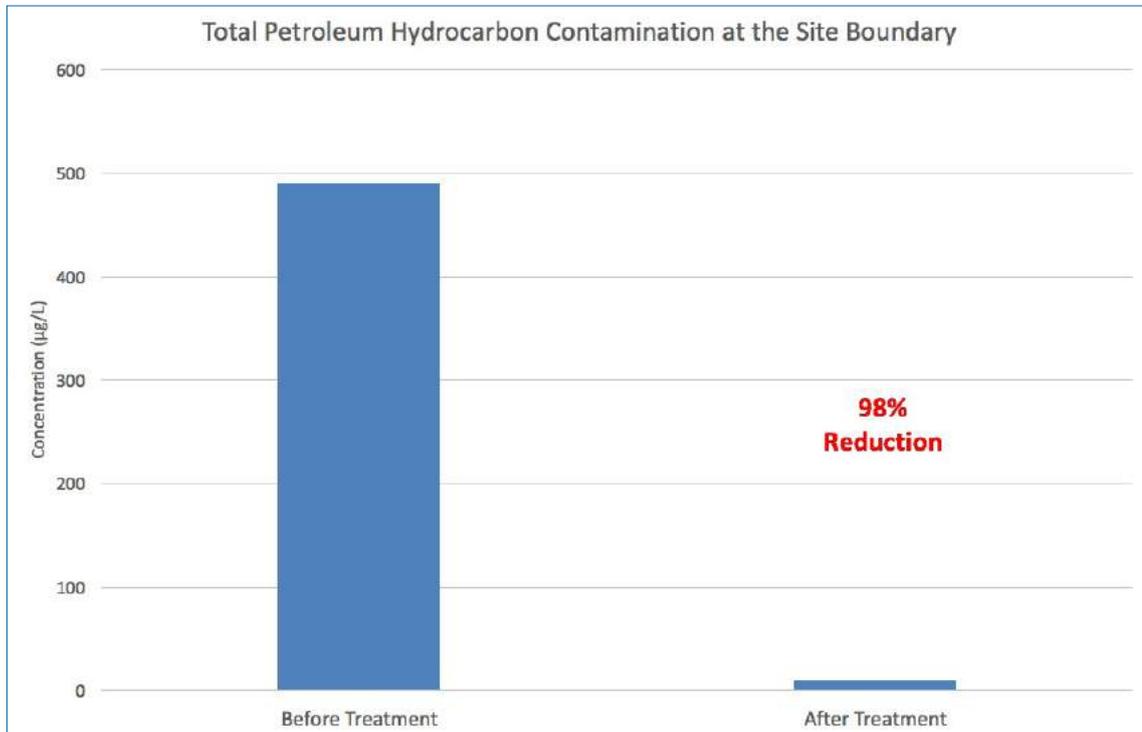
Fig. 14 - TPH concentrations at site boundary before and after PlumeStop barrier treatment

Following injection of the PlumeStop across the width of the predicted contaminant plume, the TPH concentrations at the site boundary were dramatically reduced by 98%. Although not the main focus of the treatment, low levels of PAH were also reduced to non-detect.
